TEST REPORT

Report No : CRT 2014_V0199

Title : Handling Drop Test of UL10

Comprehensive Reliability Test Korea

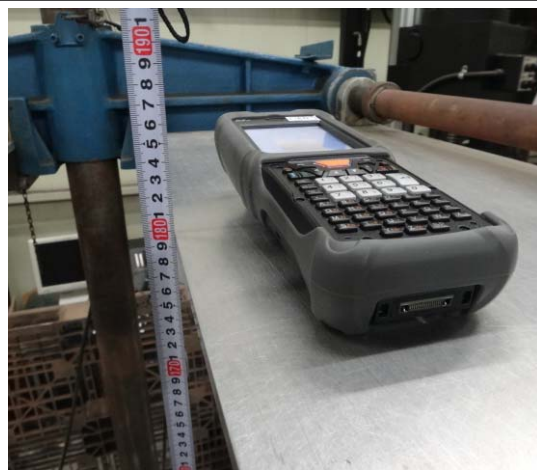
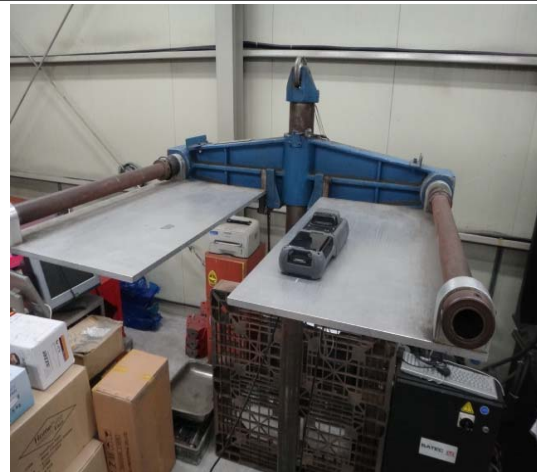
Fig 2. Photo of Specimens setting 1

Drop Test			
Type	Orientation	Number of drops	Height (m)
Free fall drop	faces (1) ~ (6)	2 times on each sides	1.8

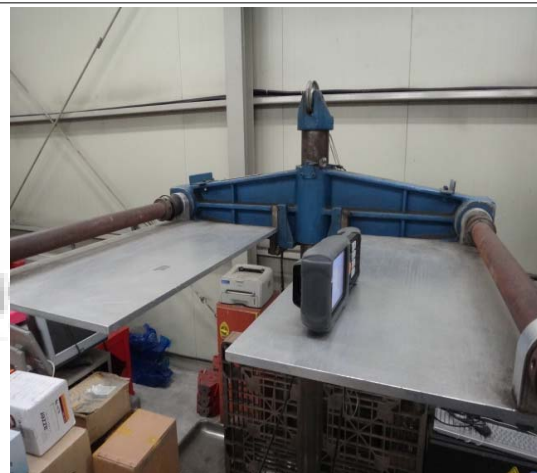
Fig 3. Photo of Specimens setting 2

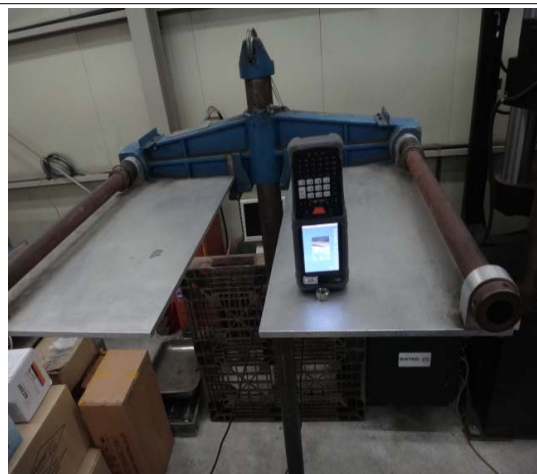
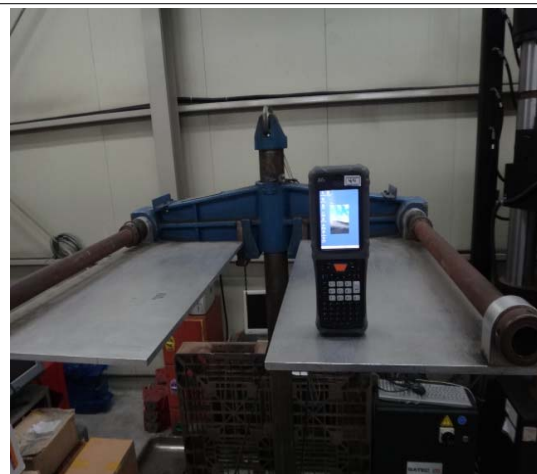
Fig 4. Photo of Specimens setting 3

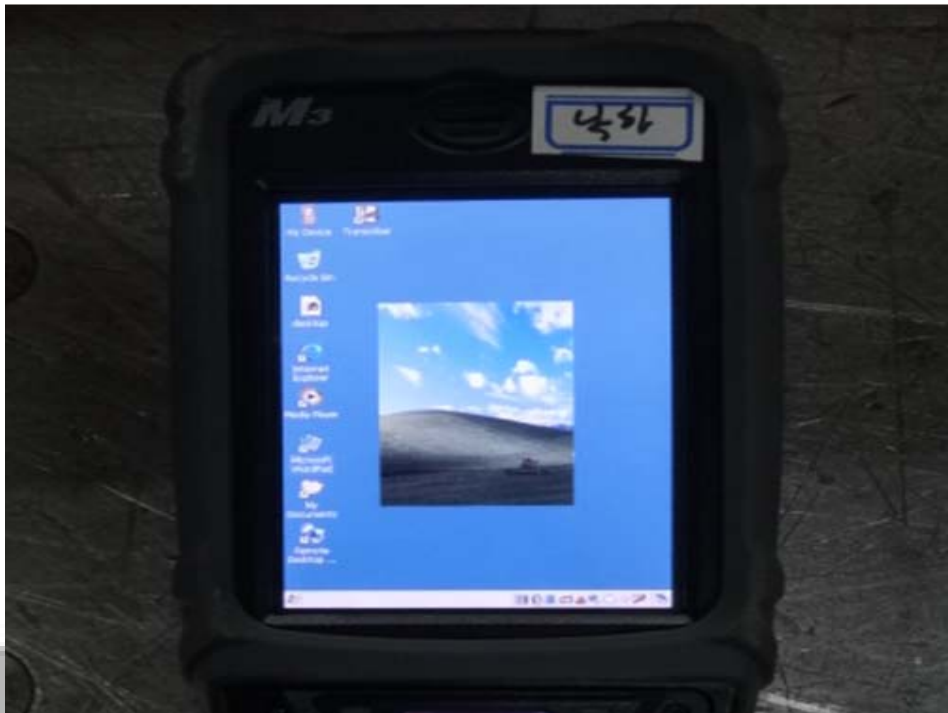
Fig 5. Initial Screen

- 1) The test parts did not show any failure such as cracks, breakage and malfunction.
- 2) Other performance tests were carried by applicant.

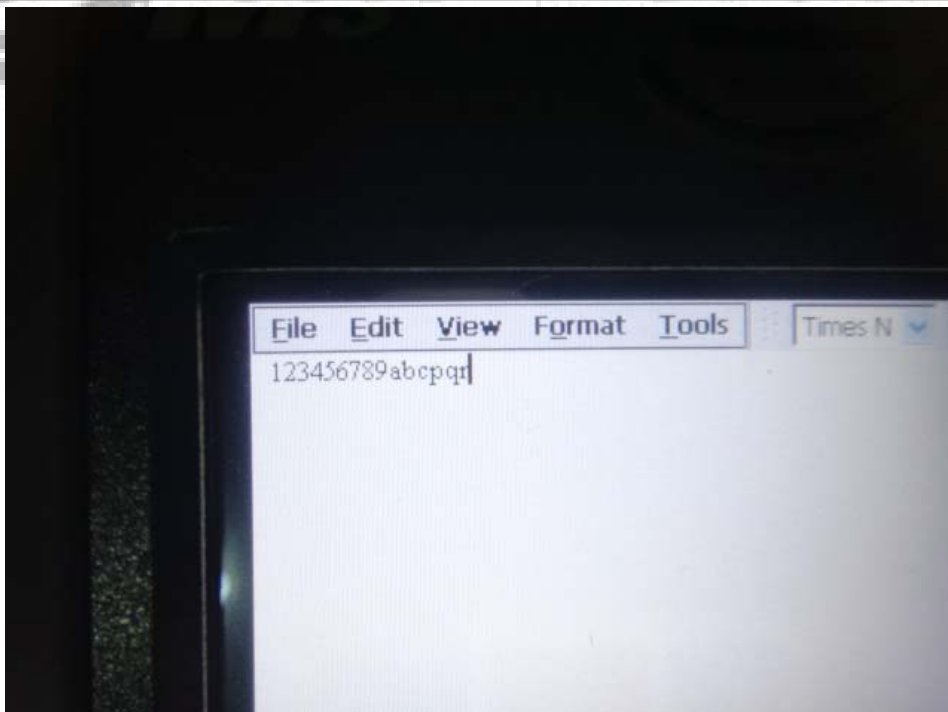
Fig 6. Notes

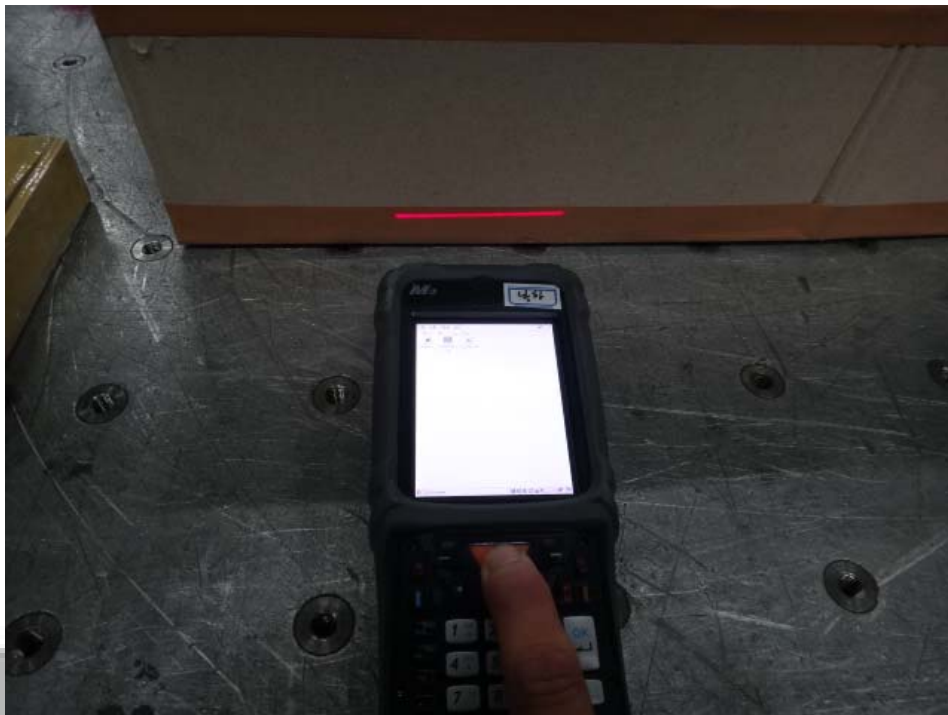
Fig 7. Scanner
